**NASA Contractor Report 159261**

VISUALIZATION OF IMPACT DAMAGE OF COMPOSITE  
PLATES BY MEANS OF THE MOIRÉ TECHNIQUE

W. G. Knauss, C. D. Babcock,  
and H. Chai

NASA Grant NSG-1483  
April 1980

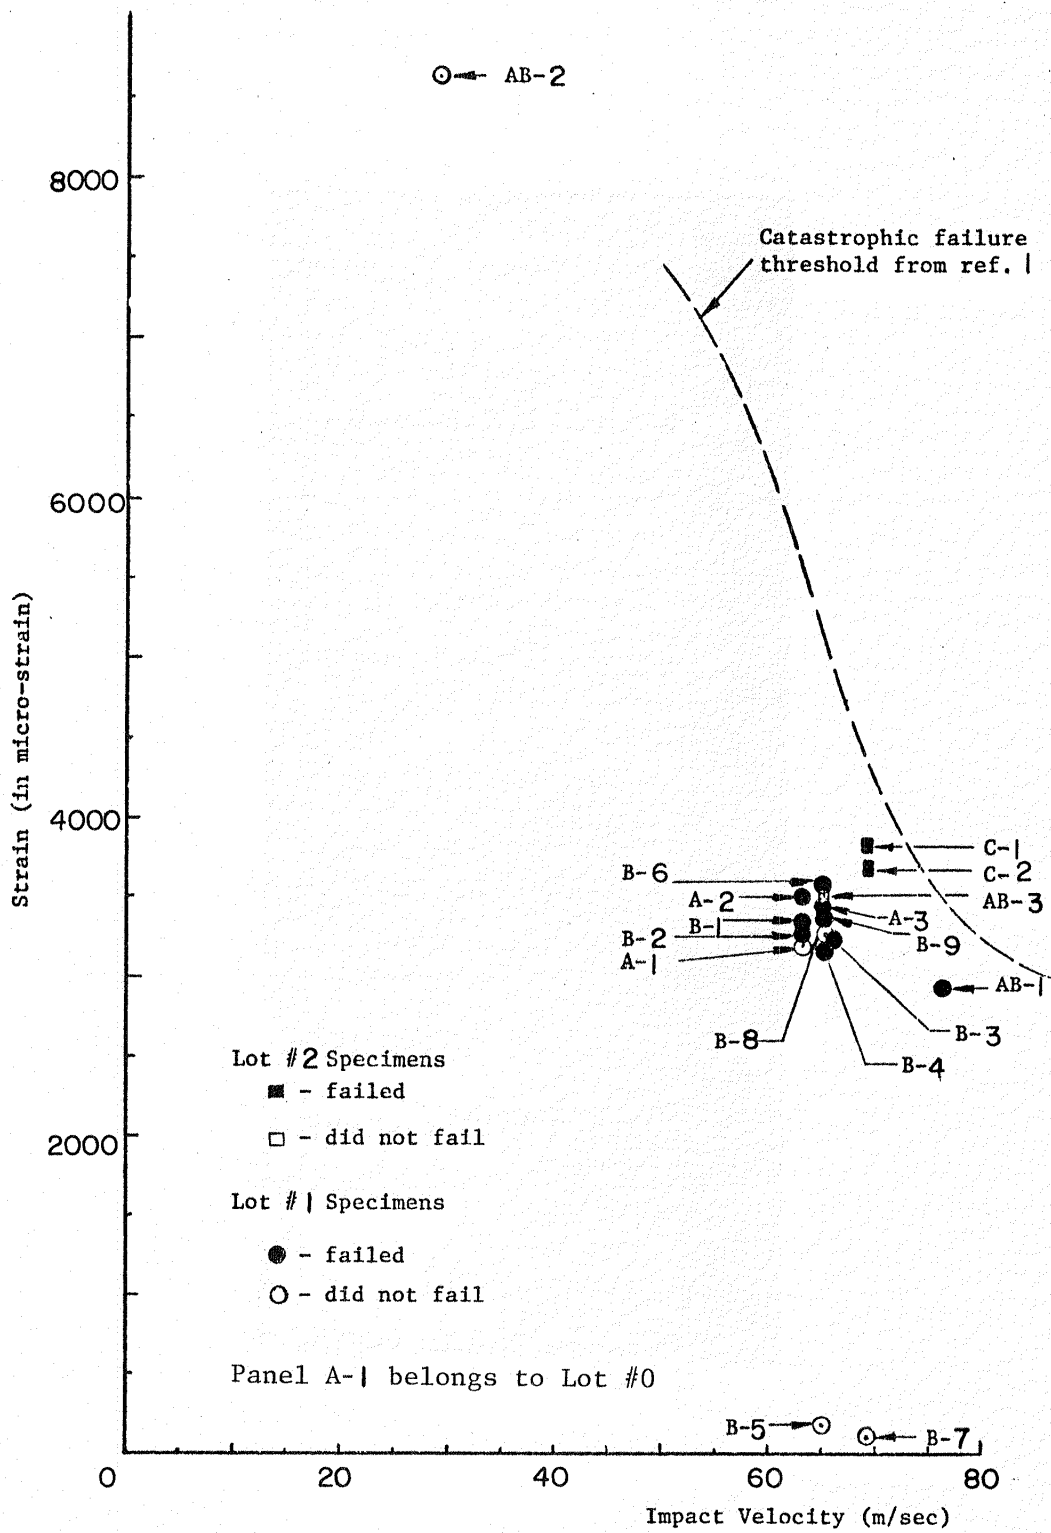
Fig. 6 Impact Experiment - Velocity vs. Strain

A total of 17 graphite-epoxy laminates were impacted at the center by a 1.27 cm (0.5 in.) diameter aluminum sphere. The panel geometry, support and test conditions are given in Table II. For convenience the data are shown in fig. 6 along with the catastrophic strength threshold curve of ref. 1. As can be seen, the majority of the tests were carried out over a narrow range of velocity. This range was selected in the middle of what appears to be a transition in the threshold curve. The selection was made in the belief that more could be learned about the initial damage and subsequent damage propagation by tests in the transition region. The test points are somewhat lower than the threshold curve of ref. 1. However, that curve was drawn with limited data in the transition range.

Another observation of interest has to do with the time at which the damage spreads after initial impact has occurred. In this connection it is well to remember that most of the experiments were conducted in the vicinity of projectile velocity of 60-70 m/sec. According to fig. 6, this falls into the steeper portion of the curve relating failure strain to projectile velocity. For most of the experiments it was quite clear that damage in the form of a displacement peak under the impact point occurred very rapidly but the damage did not spread immediately. For example, in fig. 11 it took something like 24 frames or the equivalent of 1.2 ms before the damage started to grow significantly. After it started to grow, the growth was relatively rapid. Again, by comparison fig. 8 shows that damage did not appear to grow for
